VE6WZ will be QRT from HF bands above 160m.

I wanted to share with you guys that on Tuesday Aug 27, I suffered a main lift cable failure on my crank up tower that destroyed all of my Yagi's and the US tower. At the time of the failure, I was beside the tower (doing work) in my man lift while it was going up. The tower was almost at full height (at 100') when the main lift cable broke. About 400 pounds of Yagis came crashing down almost instantly from 100'. I was in the manlift, and my reaction was to "go down" into the man basket when I heard the crash. This is what saved me. The man basket was somewhat damaged and bent. I am totally ok, with not a scratch, but the cage of the man basket protected me. There was debris, bolts, brackets, tubing, pieces of the booms flying everywhere, but somehow, the man lift was not knocked down. After the collapse, one of the 80m Yagi elements was laying on the man basket, but I was able to push it off, and lower the man lift to get out. The tower, my 80m-40m Yagis are completely destroyed. Unrepairable. The high band Optibeam is probably repairable. See photo below.

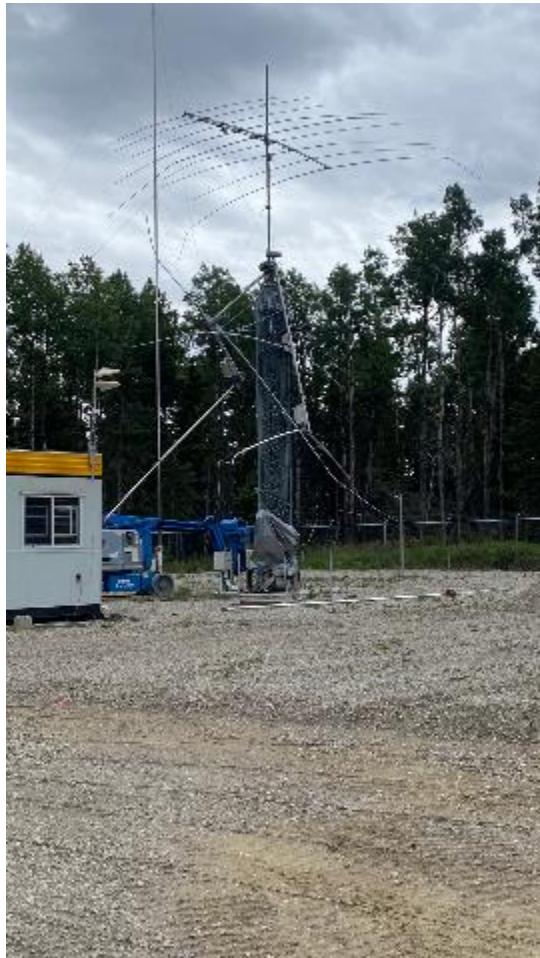
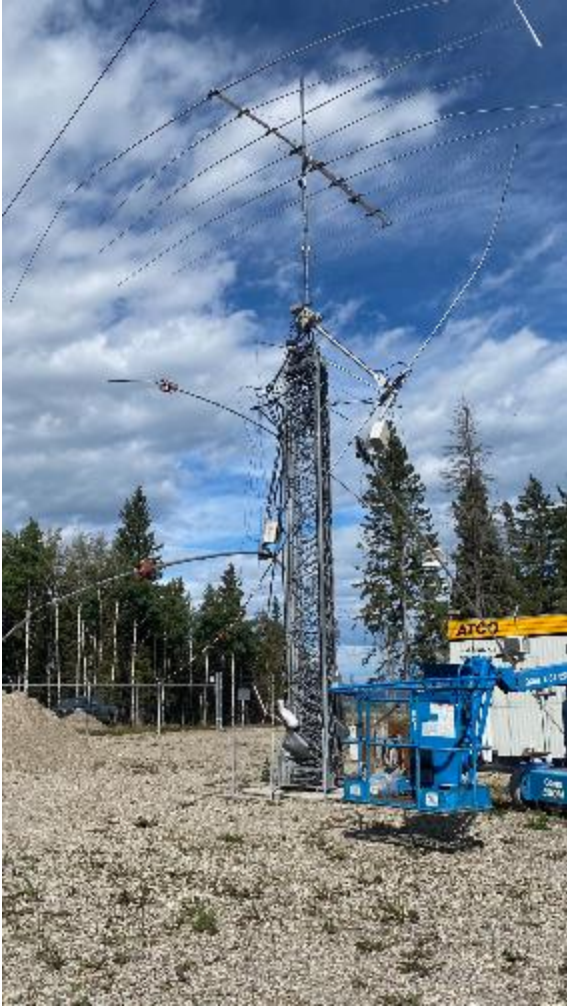
I am building a 4 element 160m, 6 direction parasitic array and needed to modify the shunt feed for the US tower crankup. The crankup is the driver for the parasitic elements. I clamped brackets to the outside of each section to support shunt-wire standoffs. These clamps were working well, but after high wind, some of the shunt wires moved and caused the support arms to bend inward. This bending shifted one (or more) of the brackets to bend INWARD into the inner moving sections, then toward the main lift cable and basically sliced the main lift cable. The point is, this failure was not something that would have happened normally, but only because of my poor engineering/ modifications.

So, going forward I have decided to "simplify" my remote operation (for now) and focus on 160m. I plan to remove (and sell for scrap) the 2,000 lb US tower, and replace it with another 90' irrigation tubing vertical to complete my 4 element triangular 160m TX array. Someday I may add an 80m vertical TX array. Or even some high band stuff. The fact is, as some of you may know, I have been marooned on 160m anyway, rarely TX above 40m, let alone 80m.
